Subject: Site Inspection Prioritization-Level II
Owens Corning Fiberglass Corp., St. Helens, Oregon
EPA ID No. ORD 09347 6109
Work Assignment C1003956
Contract 068-W9-0009

PRC Environmental Management, Inc. (PRC) has completed a Level II site inspection prioritization (SIP) for the former Owens Corning Fiberglass Corporation (Owens Corning) site in St. Helens, Oregon. The facility is currently owned and operated by Armstrong World Industries (Armstrong). The evaluation was based on a review of U.S. Environmental Protection Agency (EPA) and Oregon Department of Environmental Quality (DEQ) files and documents obtained from Armstrong as well as observations made during a site visit conducted by PRC on April 14, 1993. Attachment I contains the photographs taken during the site visit.

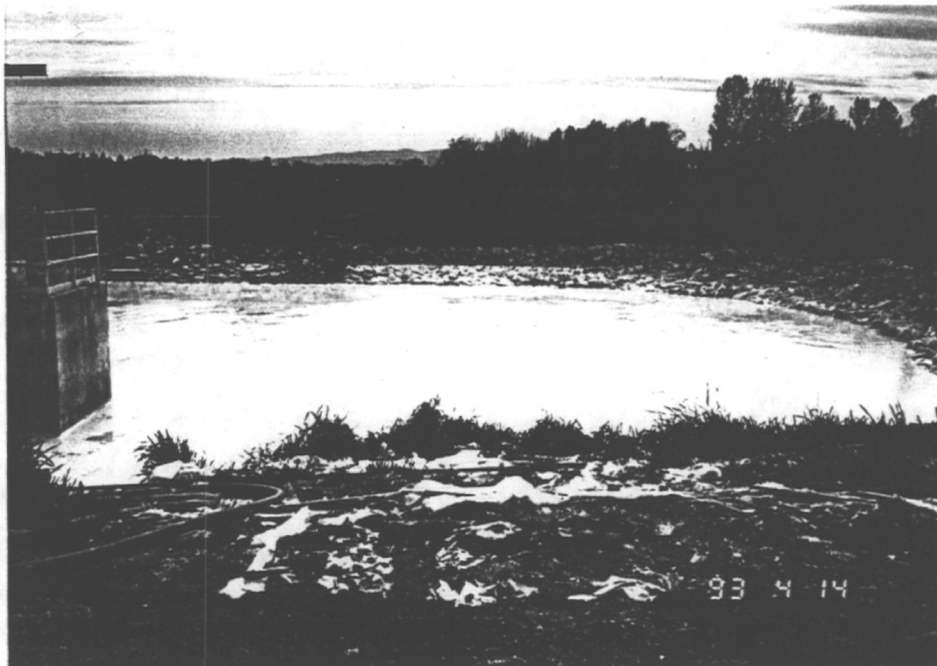
Photograph: 1	Date: 4/14/93	Taken By: Howe	Direction Facing: South
Description: Recirculation pond; former lagoon location in background

The remaining 6 inches of sediment in the aeration lagoon was mixed with sand, and the lagoon was backfilled with soil. A small portion of the northeast corner was not backfilled but was instead lined with Hypalon to create a 325,000-gallon recirculation pond. At the time of the site visit, the pond was being used as a surge pond to even out the flow into the primary clarifier. Aeration type jets are used to keep the solids in suspension until the wastewater is routed to the clarifier.

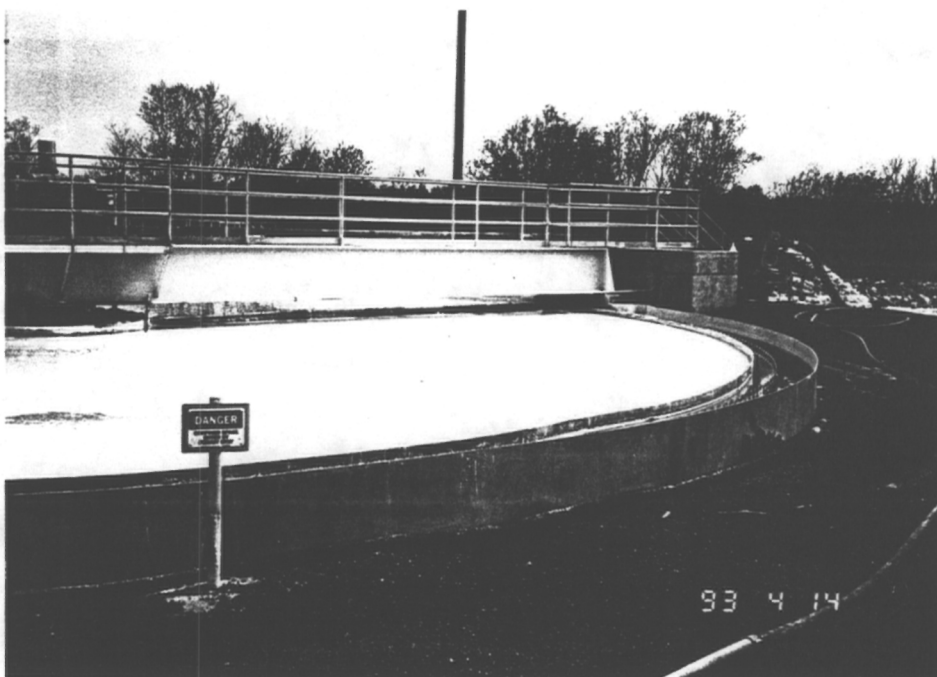
Photograph: 2	Date: 4/14/93	Taken By: Howe	Direction Facing: Southeast
Description: Primary clarifier

Currently, primary treatment is used to recover solids that are then recycled into the process. A portion of the wastewater is also reused in the process; the remainder is sent to the municipal

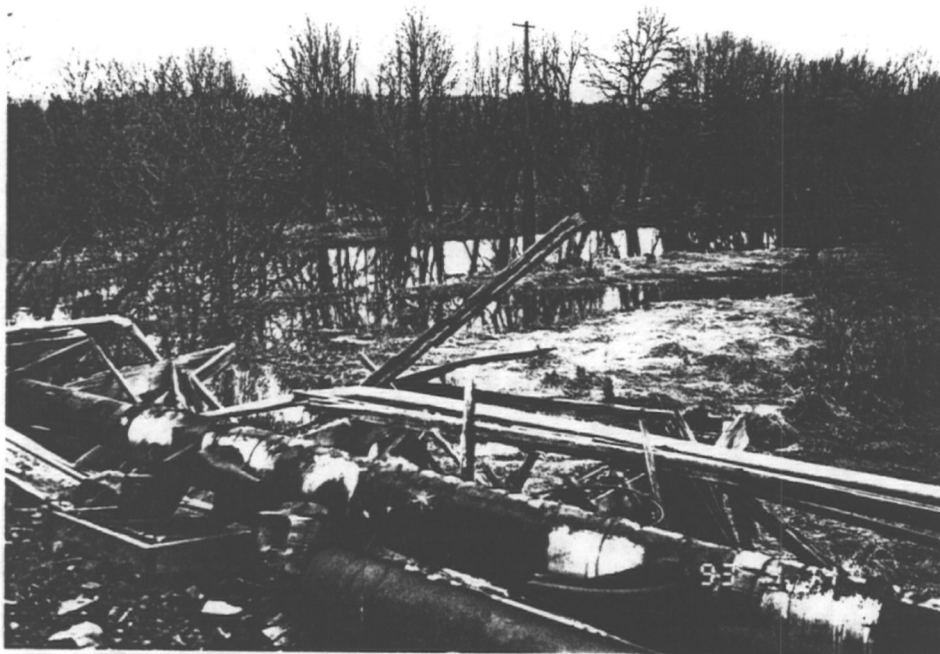
Photograph: 7	Date: 4/14/93	Taken By: Howe	Direction Facing: South
Description: Former effluent pipe and current wetlands

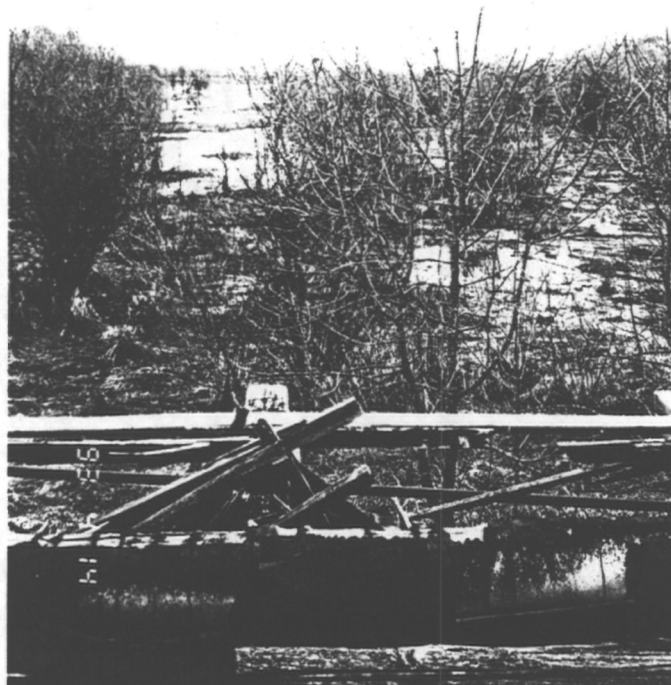
Photograph: 8

Description: Former effluent pipe (closest to front) with Scappoose Bay wetlands in background.

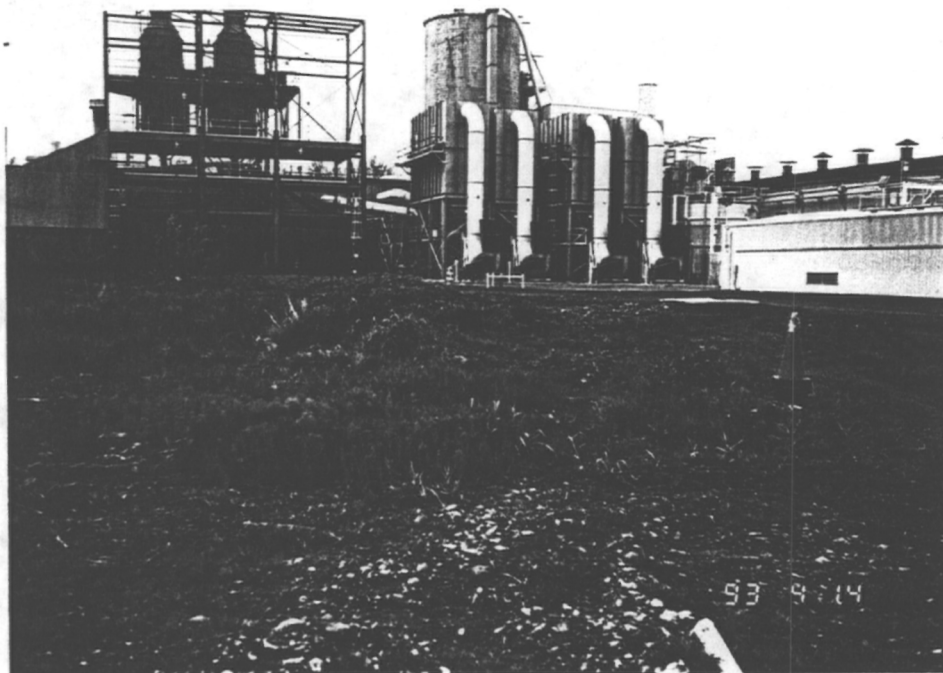
Photograph: 3	Date: 4/14/93	Taken By: Howe	Direction Facing: Northwest
Description: Location of former sludge holding pond (foreground)

Former Sludge Holding Pond. During the site visit, PRC observed some crumbly light gray material present in small patches on the surface of the sludge holding pond. Armstrong personnel stated that this material was probably the sludge that was deposited after it was removed from the aeration lagoon. The remaining surface of the former pond was heavily vegetated. The area of the former sludge holding pond was just under 20,000 square feet and it was approximately 10 feet deep.

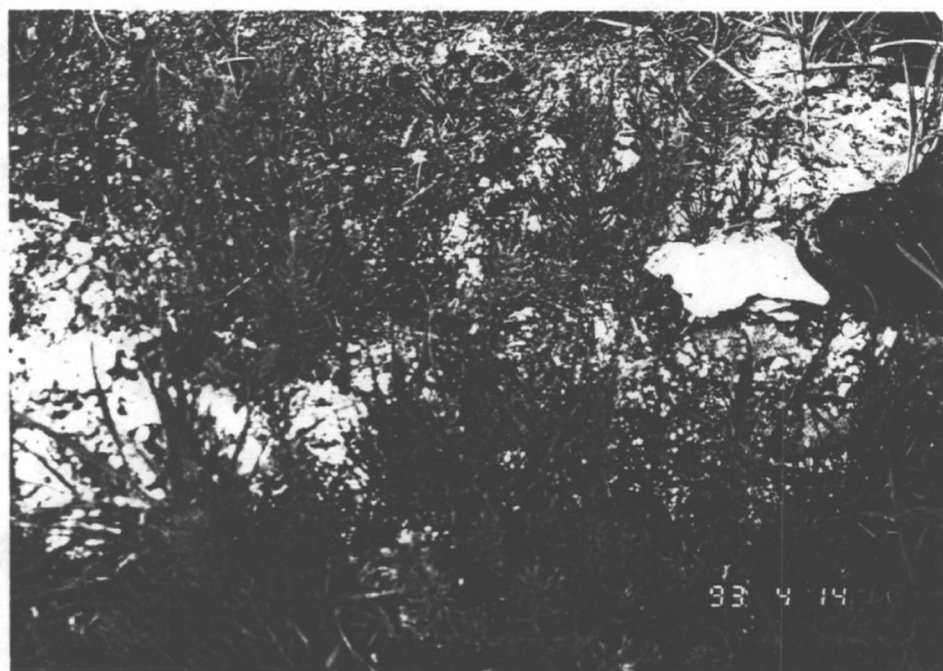
Photograph: 4	Date: 4/14/93	Taken By: Howe	Direction Facing: N/A
Description: Surface of former sludge holding pond

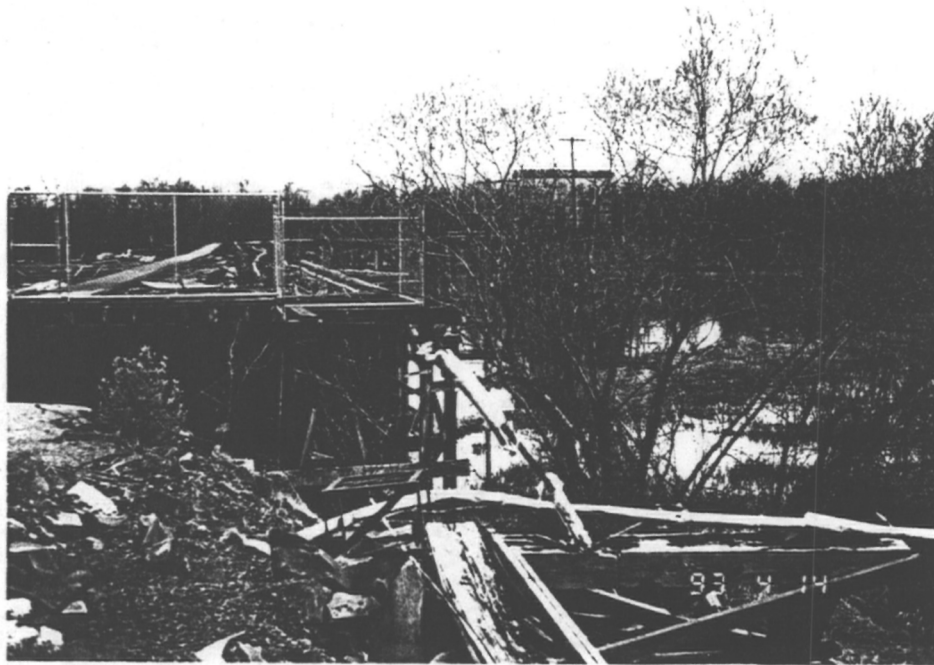
Photograph: 5	Date: 4/14/93	Taken By: Howe	Direction Facing: Southeast
Description: Former outfall location (at reddish building in background) and old pier

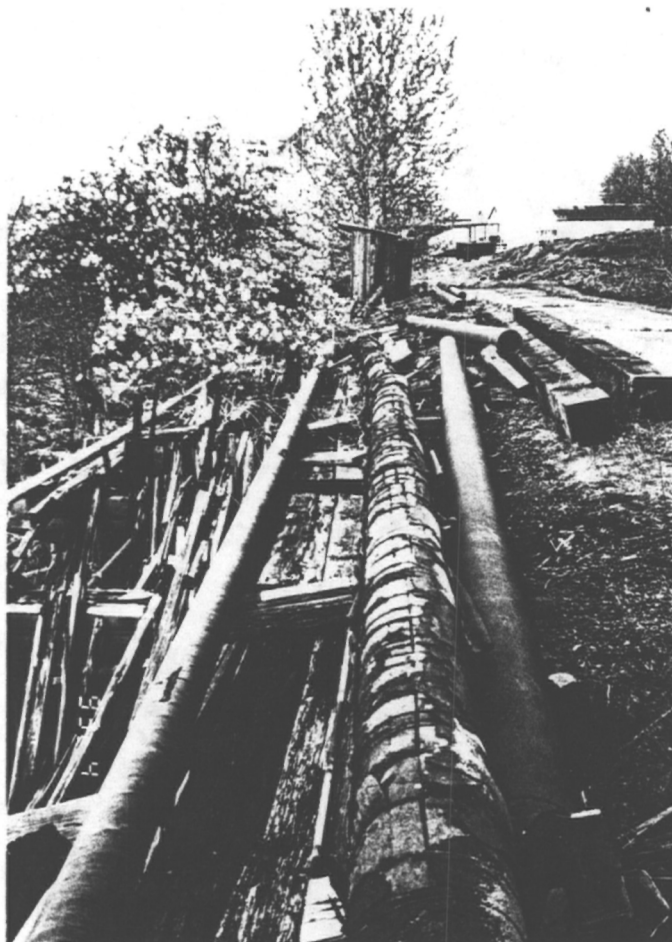
Photograph: 6
Date: 4/14/93
Taken By: Howe
Direction Facing: Northwest
Description: Old effluent pipe (center), and water intake pipes.

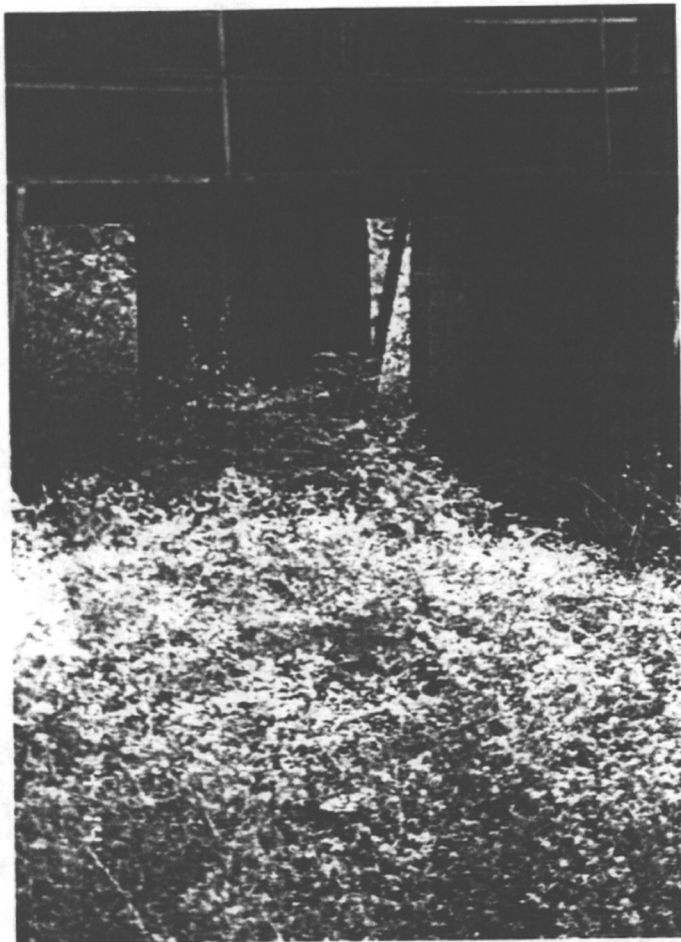
Photograph: 9

Description: Monitoring well MW1 in front of old asphalt/naptha tank structure.

The only significant contamination reportedly found during the survey was associated with the aboveground asphalt-naphthalene tank located near the Quonset hut. An area between the Quonset hut and the tank was identified as being covered with "asphalt-naphtha like material." The material had also been deposited along and over an embankment located northeast of the Quonset hut.

In October 1987, two monitoring wells were installed by CH2M Hill, and groundwater samples were collected and analyzed for volatile organic compounds, semivolatile organic compounds, and oil and grease. Trace amounts (3 ppb) of toluene were detected in the sample from MW-1, and methyl isobutyl ketone was detected in the MW-2 sample (5 ppb). In addition, 11 ppb of bis-2-ethylhexyl phthalate was found, and 3 ppm of oil and grease were detected in both wells.

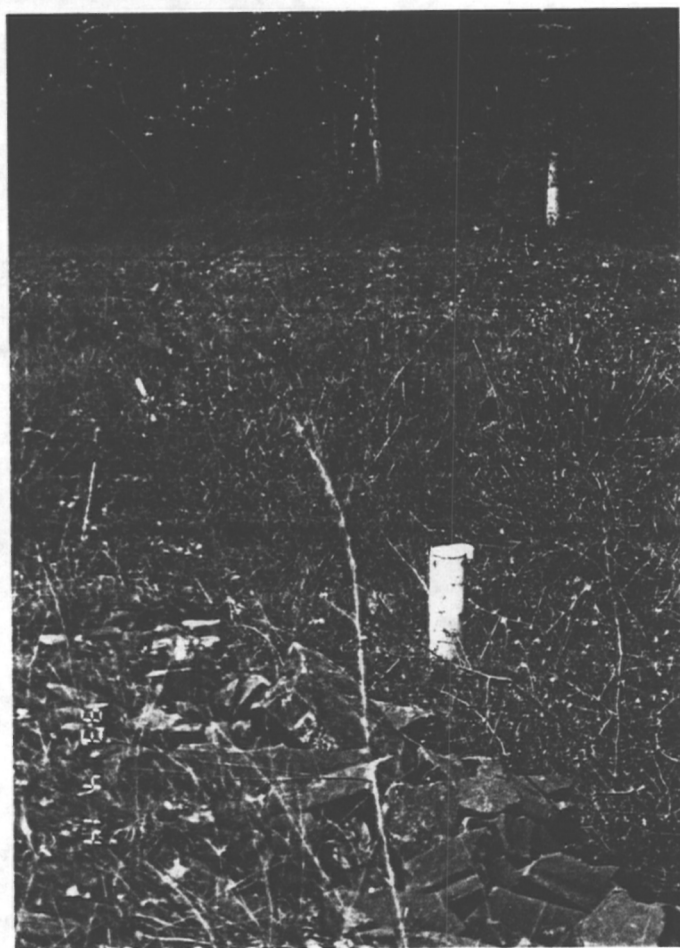
Photograph: 10

Description: Monitoring well MW1 in area of potential past spillage

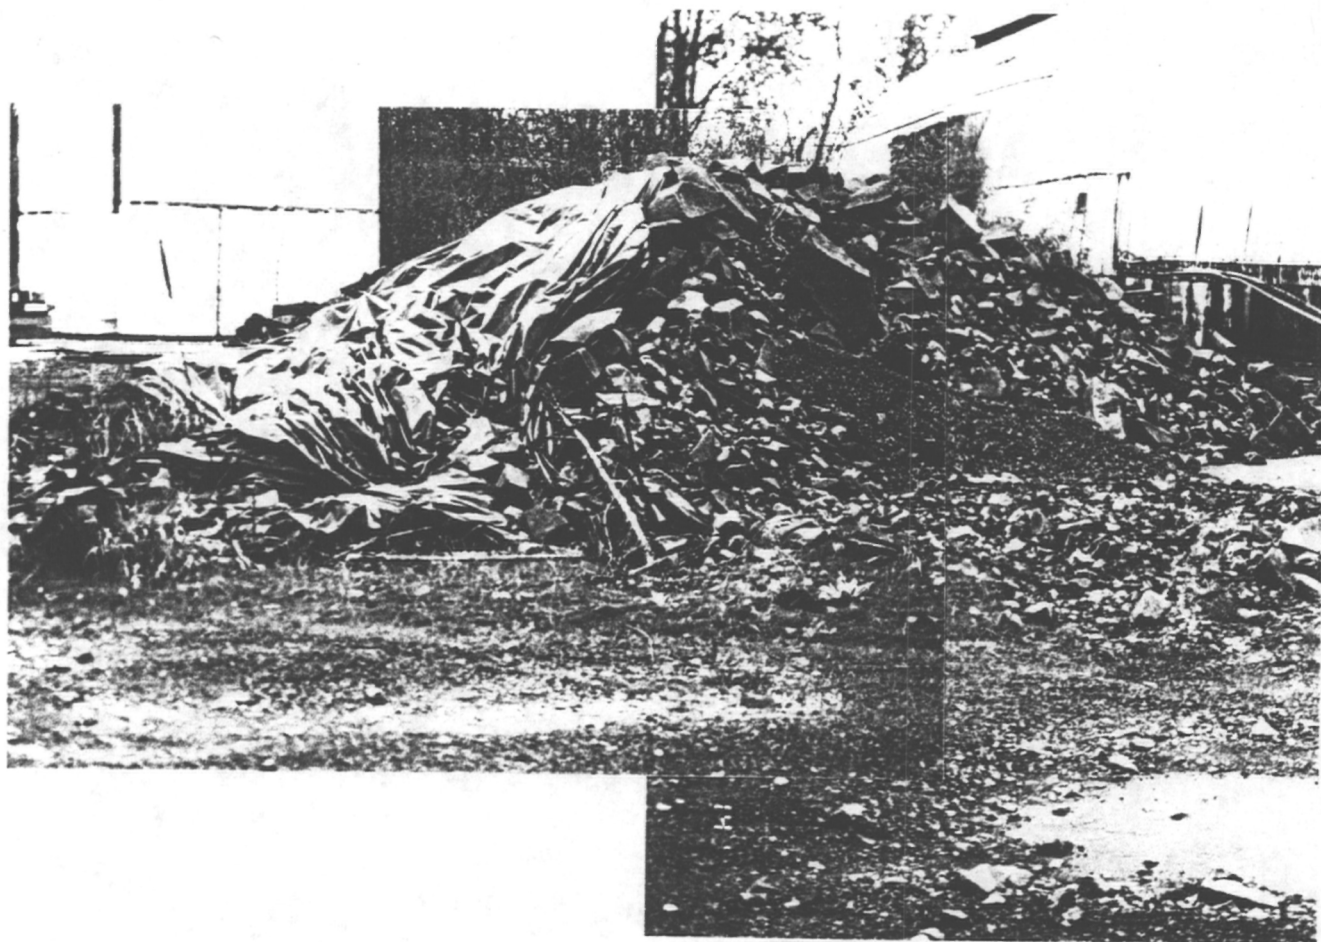
Waste Pile Containing Contaminated Soil. During the site visit conducted by PRC, a waste pile containing contaminated soil that had been excavated was present in the area of the Quonset hut. It appeared that the pile had once been covered with plastic; however, most of the pile was exposed to the elements. The dimensions of the waste pile were estimated to be 15 by 20 by 8 feet high.

Photograph: 11	Date: 4/14/93	Taken By: Howe	Direction Facing: Southwest
Description: Waste pile of soils excavated near the quonset hut

No further action by the Superfund Program is recommended at this site; however, the waste pile of contaminated soils and any remaining soil contamination in the vicinity of the Quonset hut should be assessed and removed under the guidance of the appropriate regulatory authority. No sampling by EPA is recommended at this time.

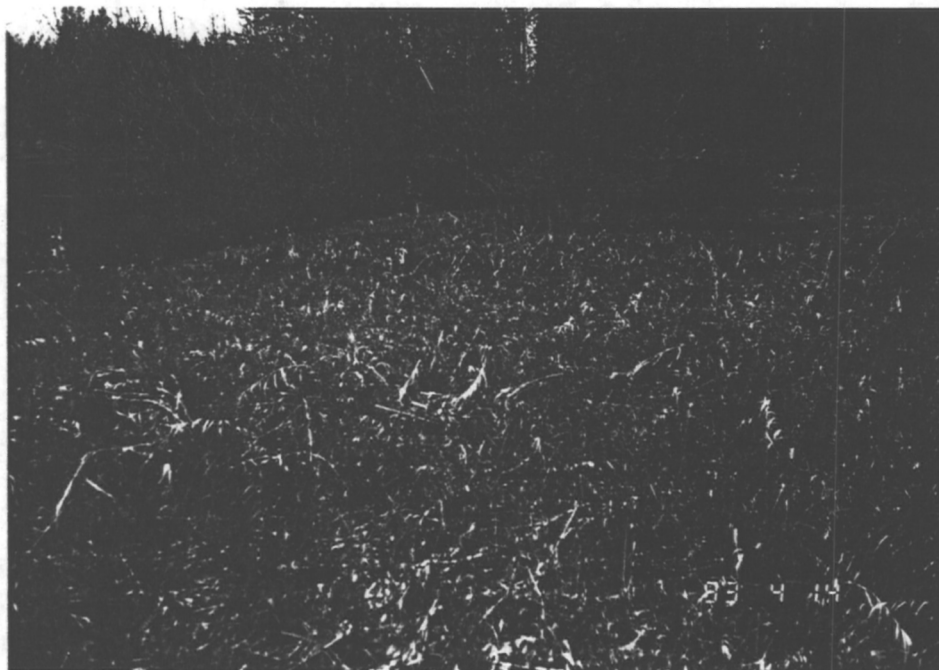
Photograph: 12	Date: 4/14/93	Taken By: Howe	Direction Facing: North
Description: Location of former burn area

Asbestos was used in limited quantities as a raw material in the early 1960s, and material burned on site may have contained asbestos. A burn area was used for solid wastes such as crates, reject fiberboard, and other fairly inert wastes. In 1986, Owens Corning collected surface soil samples for asbestos analysis. No asbestos was detected in the sample from the burn area. No sign of the burn area could be seen during the site visit. Several underground storage tanks (containing fuel) and aboveground storage tanks were also investigated. According to Armstrong, CH2M Hill was hired to empty and clean out all of the tanks. A former aboveground tank farm was used to store fuel, asphalt, and caustic. The survey report (CH2M Hill 1987) stated that, other than some minor surface stains, there were no visible signs of spillage or leakage from these tanks.

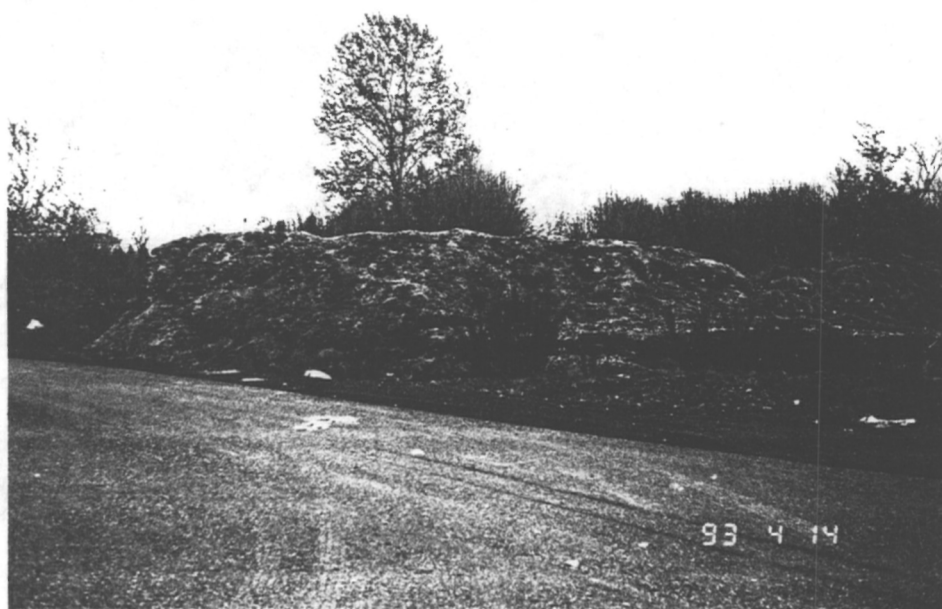
Photograph: 13	Date: 4/14/93	Taken By: Howe	Direction Facing: Unknown
Description: Old sawdust pile

SRH also sampled sawdust piles and a waterline trench that appeared to be contaminated. Samples from the sawdust piles contained a total petroleum hydrocarbon (TPH) concentration of 750 ppm. The waterline trench sample contained 52,000 ppm TPH.
